Manhole Inspection Summary

Manhole # S25KK_003MH

Location Address: **1001 MADISON AVE**

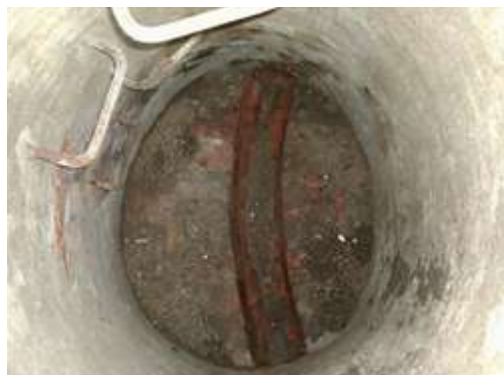
Top View

Corroded steps. Bench and Channel debris.

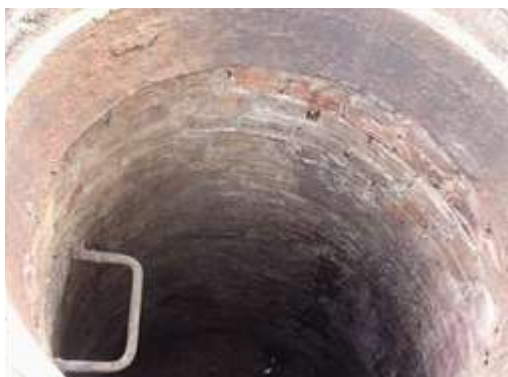
Defect

Frame leaks. Adjustment deterioration and infiltration. Corbel and Barrel infiltration - other side.

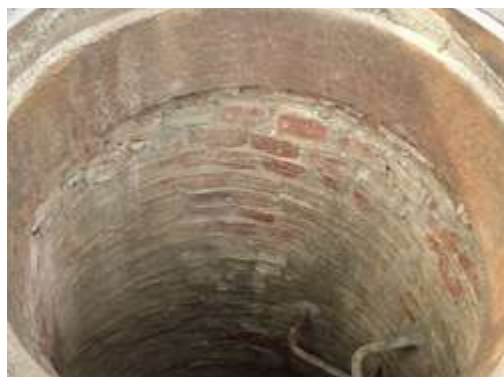
Defect

Frame leaks. Adjustment deterioration and infiltration. Corbel and Barrel infiltration.

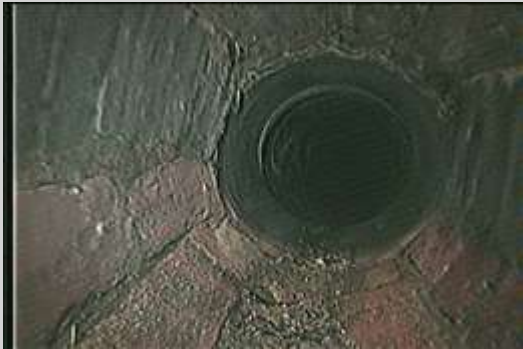
8 in. Circular Gravity Sewer Pipe Out @ 12 O'Clock

Infiltration: **Evidence** Pipe Seal Cond: **Cracked**

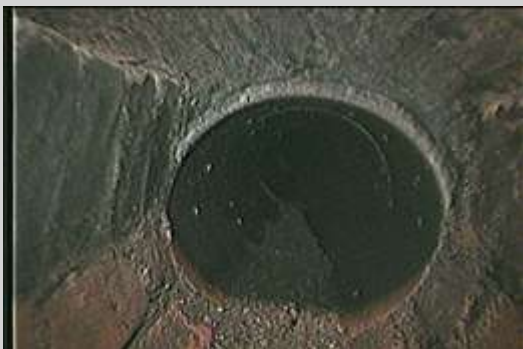
8 in. Circular Gravity Sewer Pipe In @ 5 O'Clock

Deposits: ☐ None ☒ **Mud** ☐ Sludge ☒ **Debris** ☐ Grease

Silt Depth: **0** (in.) Deposits Extent: **Light**
